NASA TECHNICAL  
MEMORANDUM

NASA TM X-64814

MSFC SKYLAB MISSION REPORT—SATURN WORKSHOP

Skylab Program Office

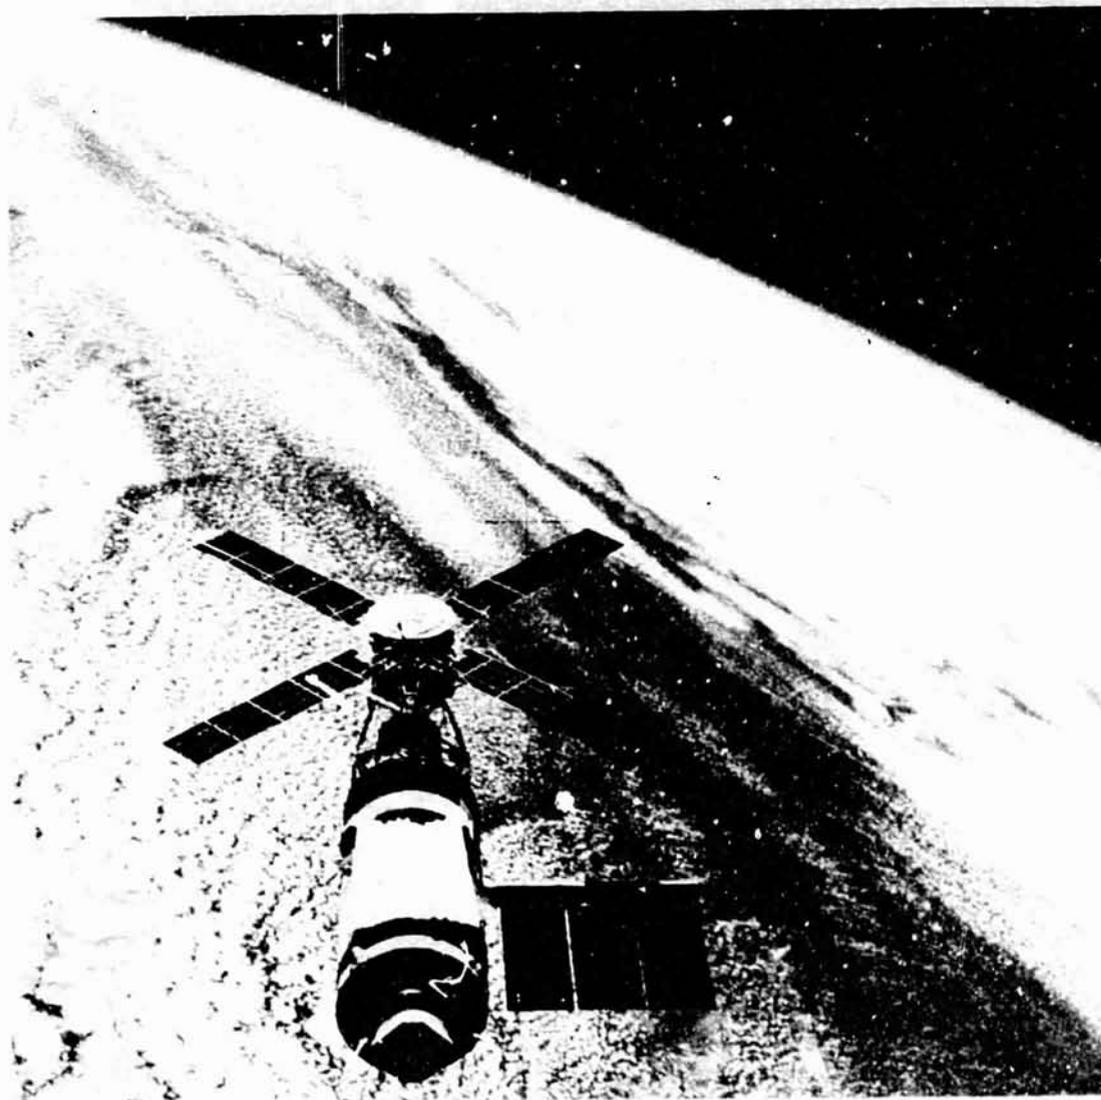
Figure 2-12.- Saturn Workshop in orbit.

Lack of thermal protection because of the loss of the shield required development and deployment of a protective thermal shield for the side of the workshop exposed to the Sun. Two different shields were used. The first was deployed during the first manned period through the +Z scientific airlock, which is on the side of the workshop normally facing the Sun. Because of potential deterioration of the material in this shield, another shield of different design was installed by the second crew during an extravehicular activity. This shield provided thermal protection during the remainder of the mission. A photograph of the final Saturn Workshop orbital configuration is shown in figure 2-12. In the photograph, two corners of the first shield may be seen protruding from below the edges of the second shield. The absence of one workshop solar array is evident.

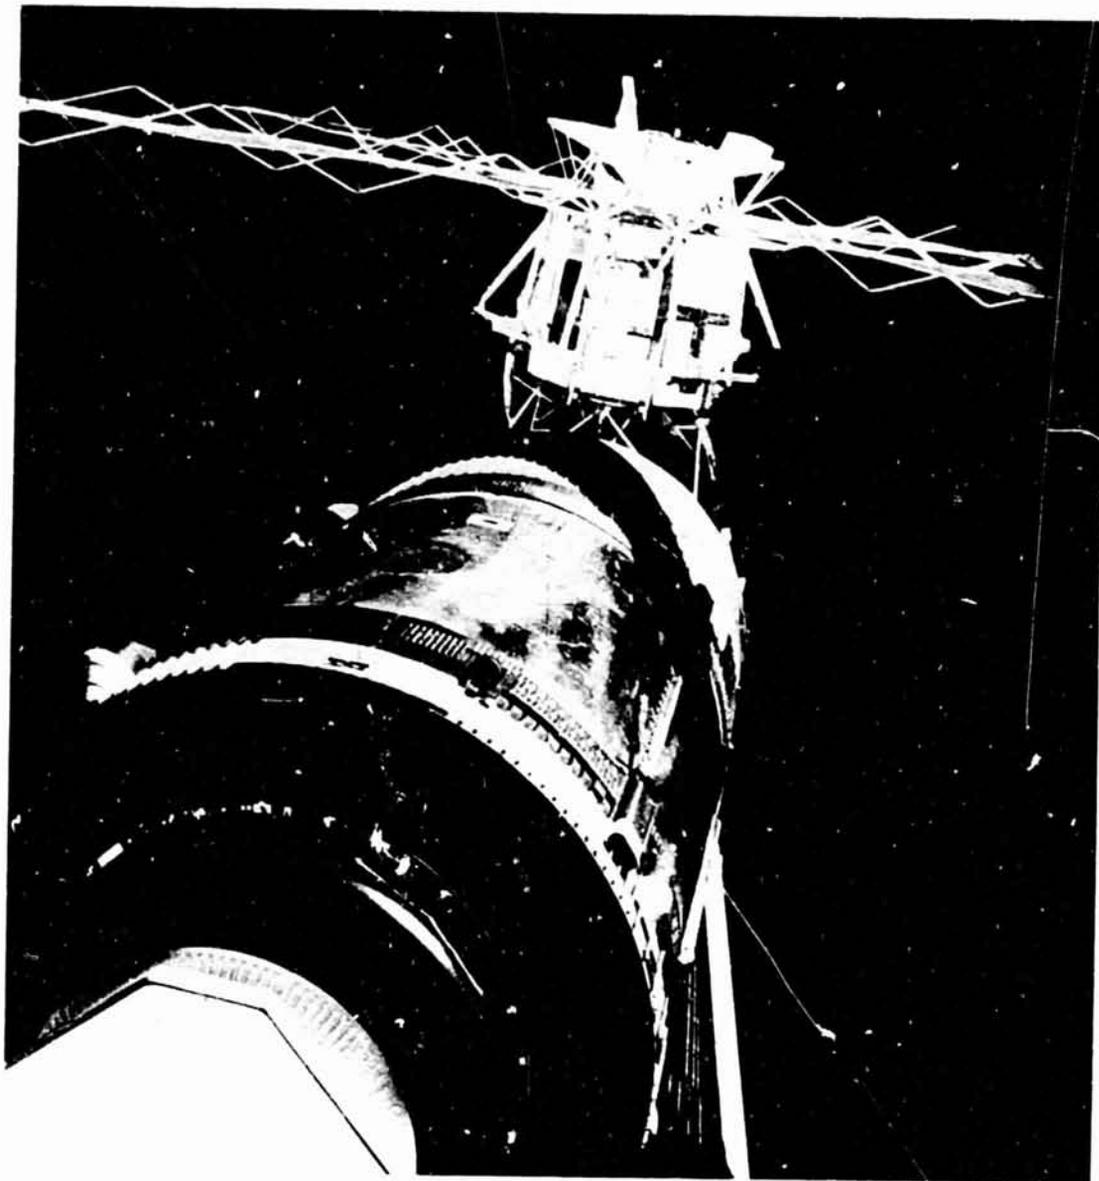
Figure 3-9.- Workshop solar array wing 1 in partially deployed position and solar array wing 2 missing.

The command and service module, on rendezvousing with the Saturn Workshop, made a flyaround inspection. During this inspection the crew described the condition of the Saturn Workshop and photographed it. They transmitted 15 minutes of live television to the ground as they crossed the United States. The crew confirmed that the meteoroid shield was missing, that workshop solar array wing 2 was missing, and that wing 1 was partially deployed and restrained by a piece of the meteoroid shield. Figure 3-9 shows solar array wing 1 partially deployed and solar array wing 2 missing.

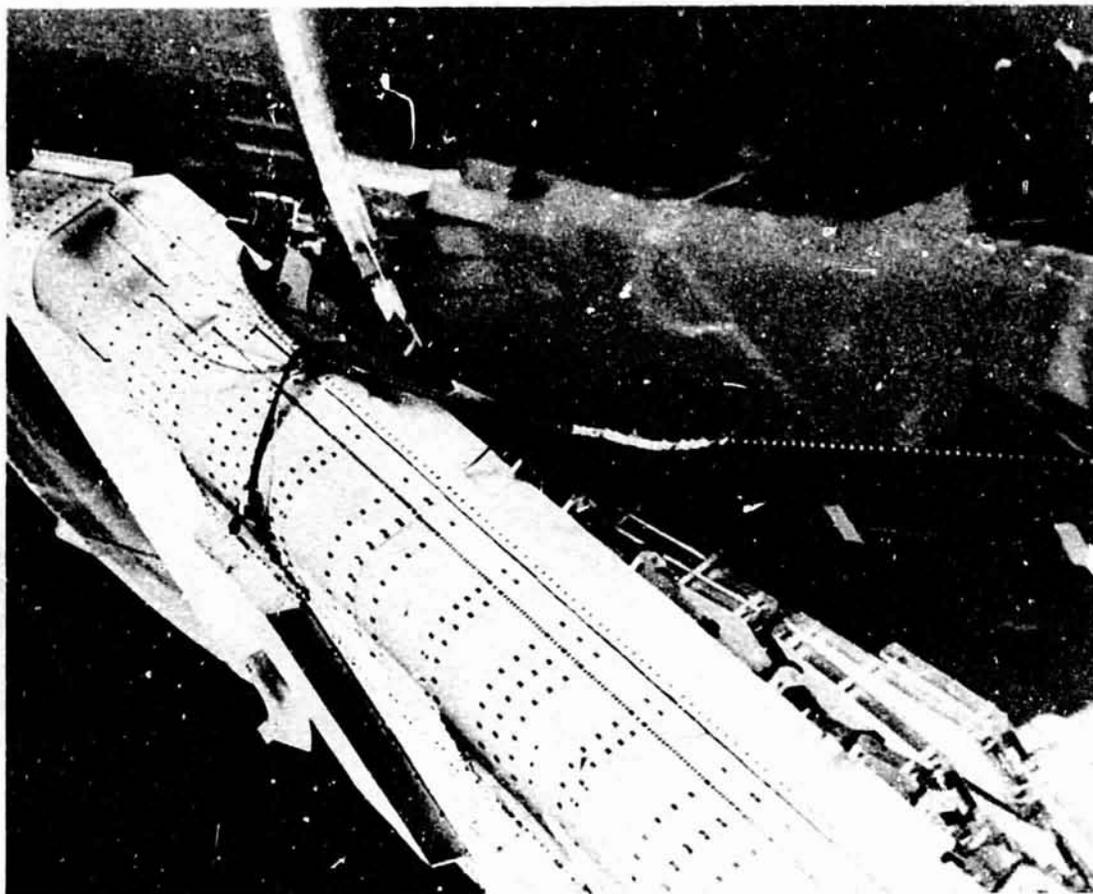
Figure 3-10.- Restraining strap on solar array wing 1 and meteoroid shield reflection.

him, and the Commander maneuvered the command and service module. The Pilot could not pry loose the strap, which was part of the meteoroid shield debris, from the beam fairing around which it was wrapped (fig. 3-10). Repeated tugging pulled the command and service module and the Saturn Workshop together. The Commander continually had to keep backing the command and service module away to avoid collision. The Saturn Workshop used a large amount of thruster gas to maintain stability in the unsuccessful attempts to free the beam.

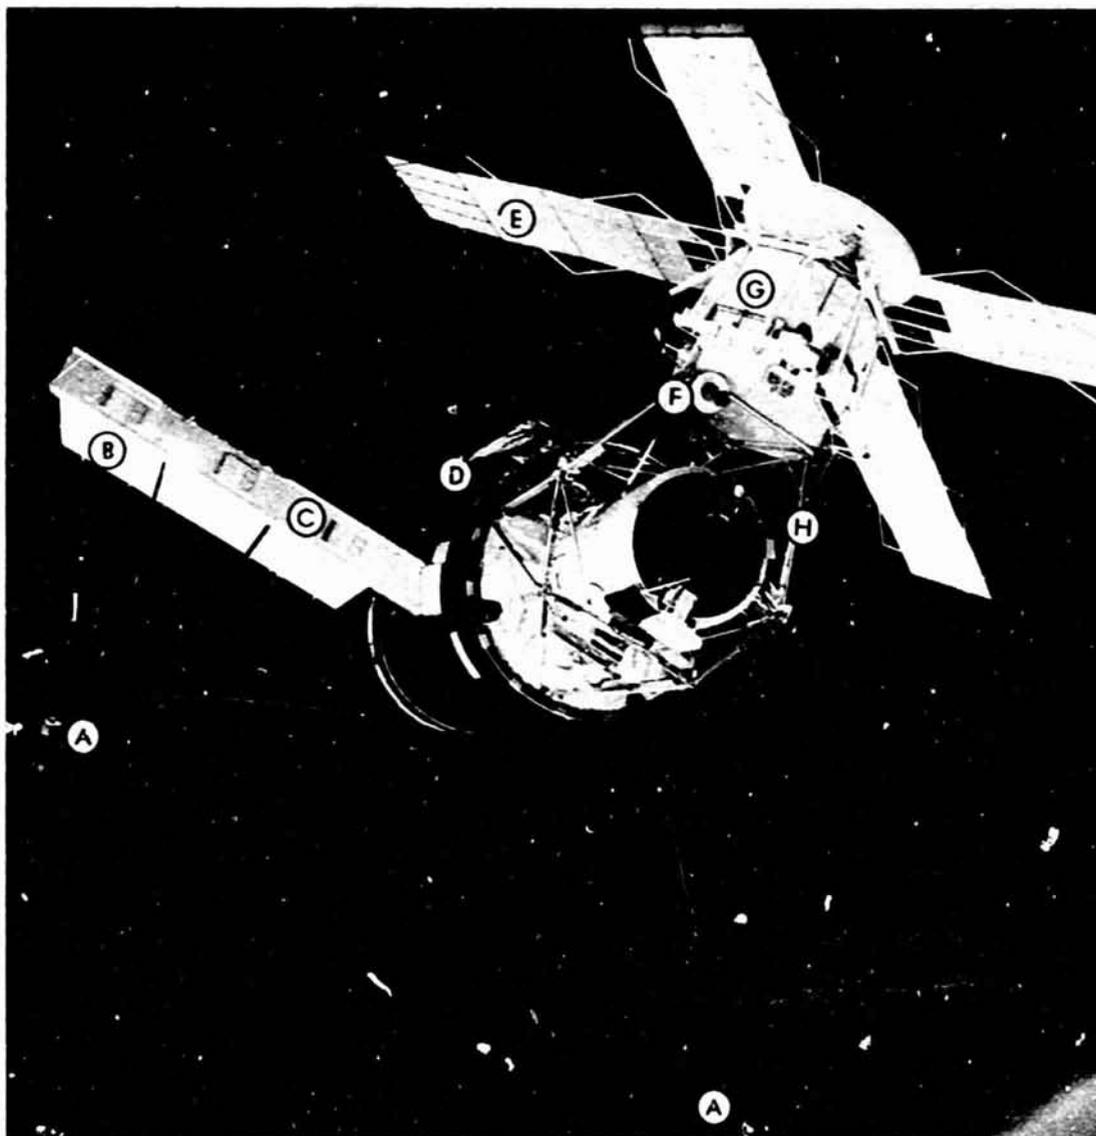
Figure 4-6.- Saturn Workshop with all elements deployed.

| C. Solar array beam fairing | G. Solar observatory |
| D. Parasol thermal shield | H. Deployment truss |

Saturn Workshop data were downlinked during launch by the 2-watt transmitter. During the mission it and five 10-watt transmitters were used with their associated RF equipment operating in the VHF band. The flow of data was maintained by providing the maximum number of ground stations that could be economically accommodated and by using transmitters with sufficient output power driving antennas of the correct type and location on the vehicle structure to provide adequate antenna coverage and signal gain. Figure 5-5 shows the antenna locations. Several of these antennas are shown in Figure 4-6 also.

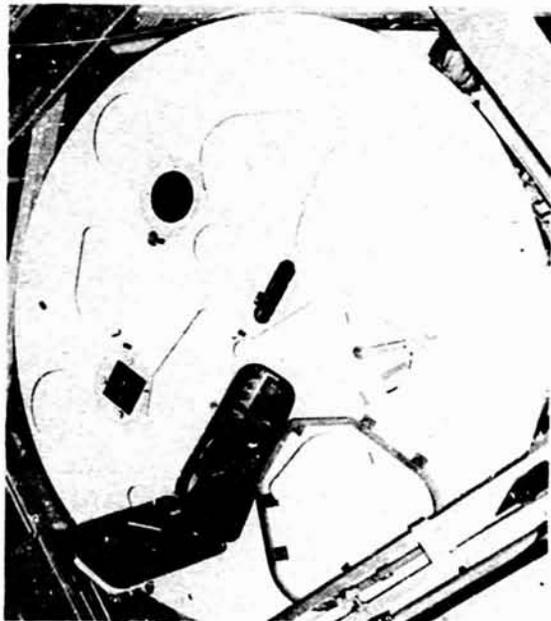
Figure 4-10.- Doors on Sun end of canister.

**Aperture.**- Each solar observatory experiment instrument in the canister is equipped with an aperture door for thermal and contamination control (fig. 4-10).

The doors are identical except in size and shape. Each is a fiberglass shell containing multilayer insulation, with a shaft at one corner for opening and closing. Opposite the shaft, a tapered latch, fitting into a U-shaped, ramp-latch stop attached to the sunshield, holds the door closed during ascent. A bulb-shaped seal of silicone rubber covered with low-friction cloth, attached to the perimeter of the door's face, seals the aperture at the ramp. An identical mechanism (fig. 4-11) comprising two electric motors, a threaded spindle, a carriage, a lever, and limit switches opens and closes each door. The two motors, either singly or together, rotate the spindle to move the carriage and the lever and shaft. The limit switches stop the motors when the door is fully open or closed. The doors and mechanisms were designed for 5000 opening and closing cycles, but only 3 of the 10 doors continued to operate normally for the duration of the mission (4.3.3). The ultraviolet spec-

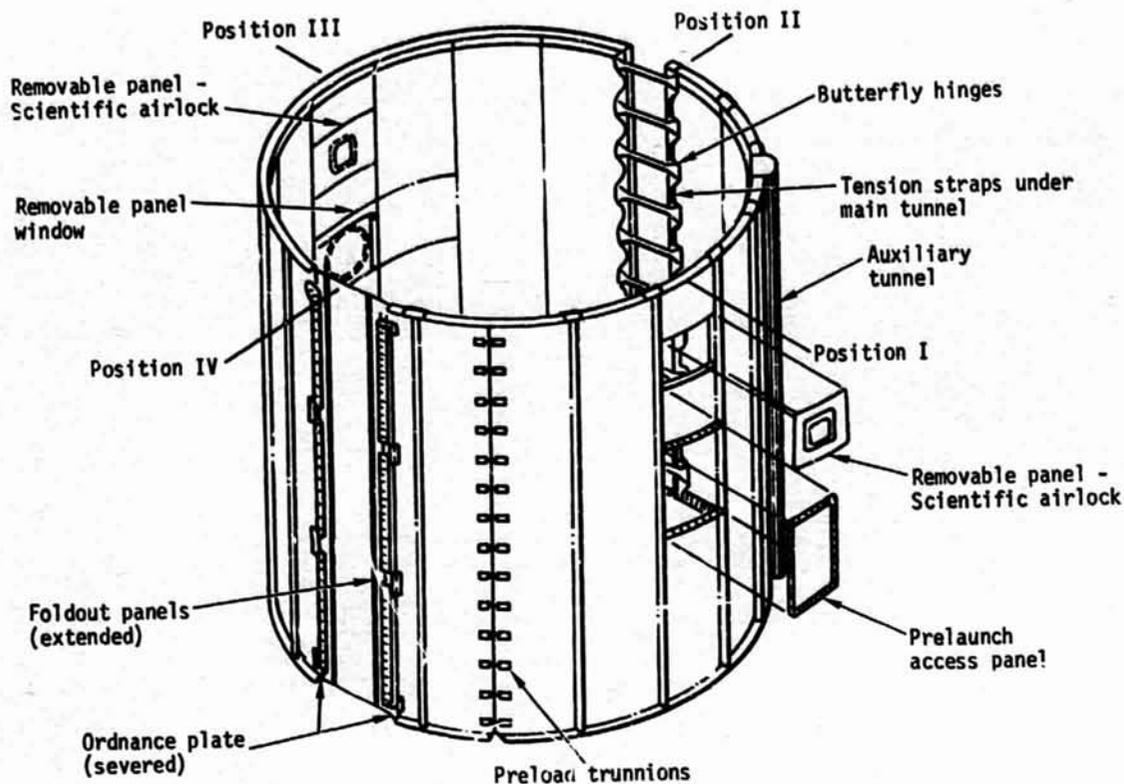
Figure 4-12.- Meteoroid shield.

Proceeding clockwise from the tension straps and butterfly hinges in figure 4-12, the next special feature is the auxiliary tunnel. This tunnel extended in an arch between panels of the thin meteoroid shield. The 28 arch-shaped titanium

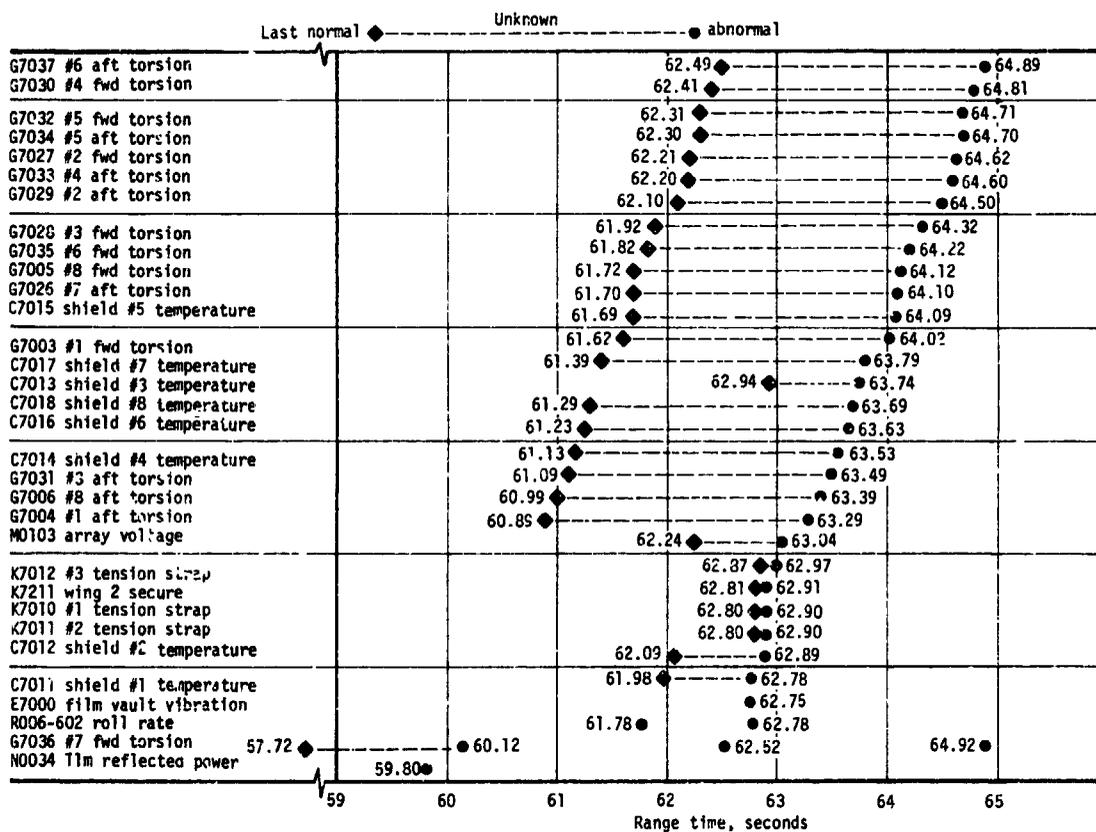
Figure 4-16.- Time sequence of 63-second anomaly instrumentation.

At 62.78 seconds, C7011, a temperature measurement, was lost. This measurement failure could have been caused by damage to the sensor or its cabling, shown in figure 4-16 by dashed lines. This was most likely a result of shield failure in the area between positions I and II. The measurements K7211, C7013, K7010, K7011, and K7012 can be considered normal at that time because they were normal during the previous sample and were sampled later than 62.78 seconds and still found to be normal. Since array-wing-secured indications and ordnance tension-strap indications were known to be good then, the evidence leads to two

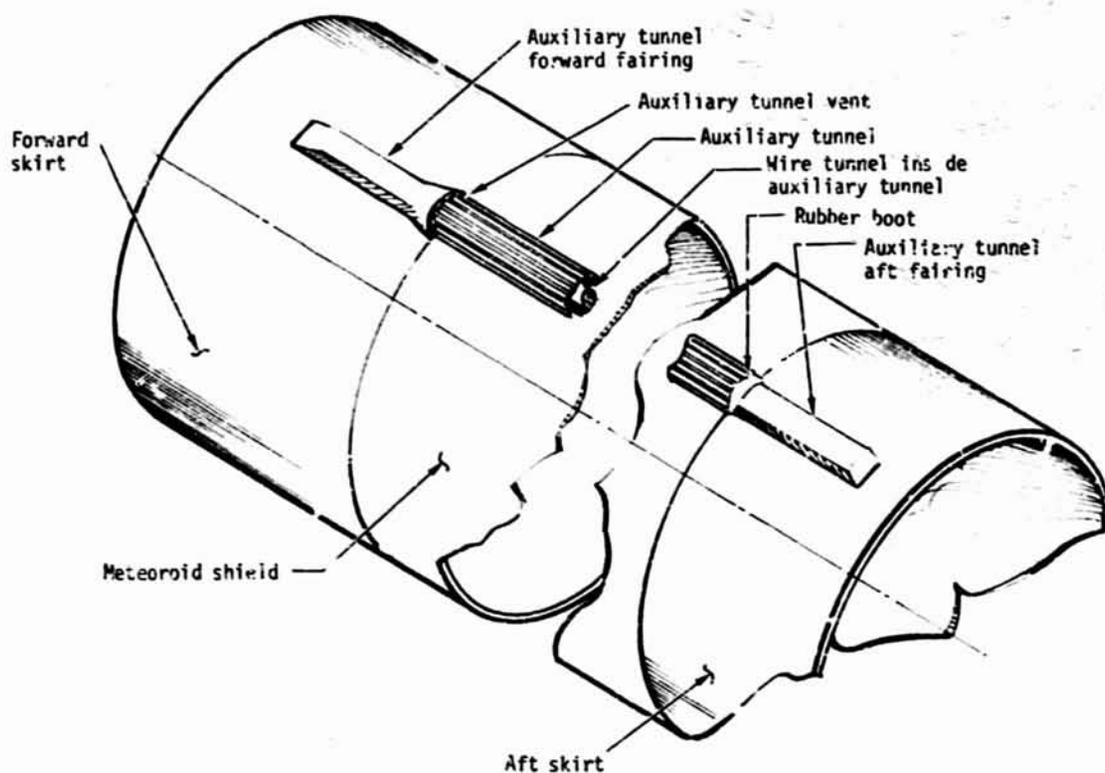
Figure 4-17.- Auxiliary tunnel.

c. An unplanned venting resulting from leakage past a molded rubber boot used to seal the movable joint at the rearward facing end of the auxiliary tunnel. A metal yoke provided a positive clamp to a molded flange on the bottom of the

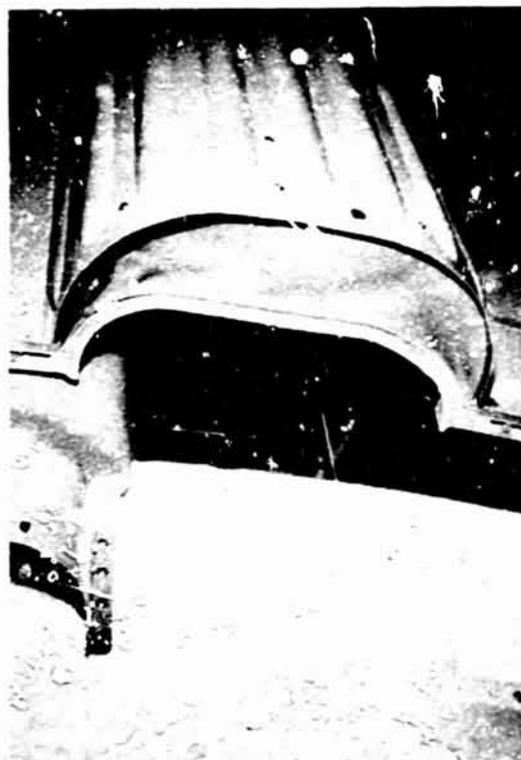
Figure 4-18.- Auxiliary tunnel boot, looking forward.

(b) Deployed position

boot over the rigid aft fairing. A bonded seal was achieved between the upper molded flange on the boot and the auxiliary tunnel. Because the auxiliary tunnel was required to lift freely away from the workshop and move circumferentially upon deployment in orbit into the position shown in figure 4-18, only a wiping butt seal could be achieved along the bottom edges of this boot "seal." When a differential pressure was applied to the boot, the butt seal deflected away from the workshop surface and created two orifices of semi-oval cross section whose size depended upon the applied pressure differential. A full-scale test was performed to determine the leakage rate at the bottom edge of the rubber boot, and this indicated that a pressure-dependent leakage area of 1.8 in.<sup>2</sup> would occur under the flight environment existing at 63 seconds.

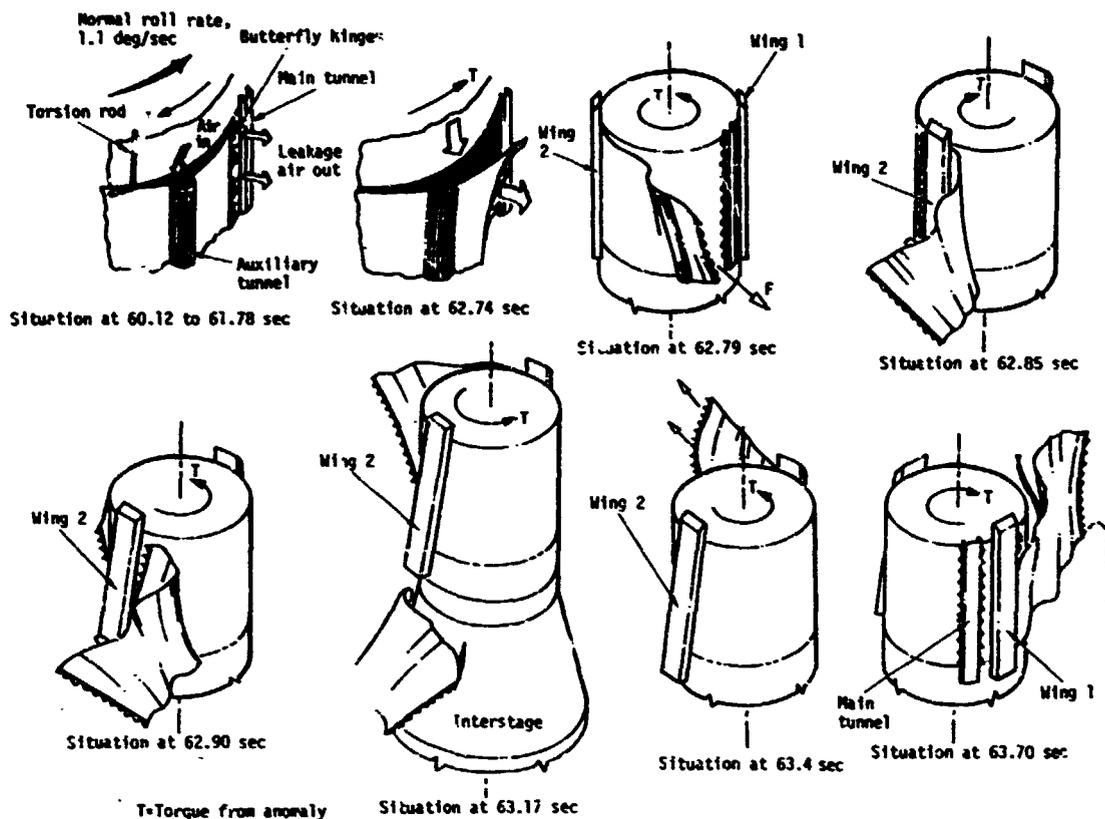
Figure 4-21.- Meteoroid shield dynamics.

The postulated sequence of the most probable failure mode is shown in figure 4-21. The events are designated on the figure by times which are consistent with the available data, and are described below:

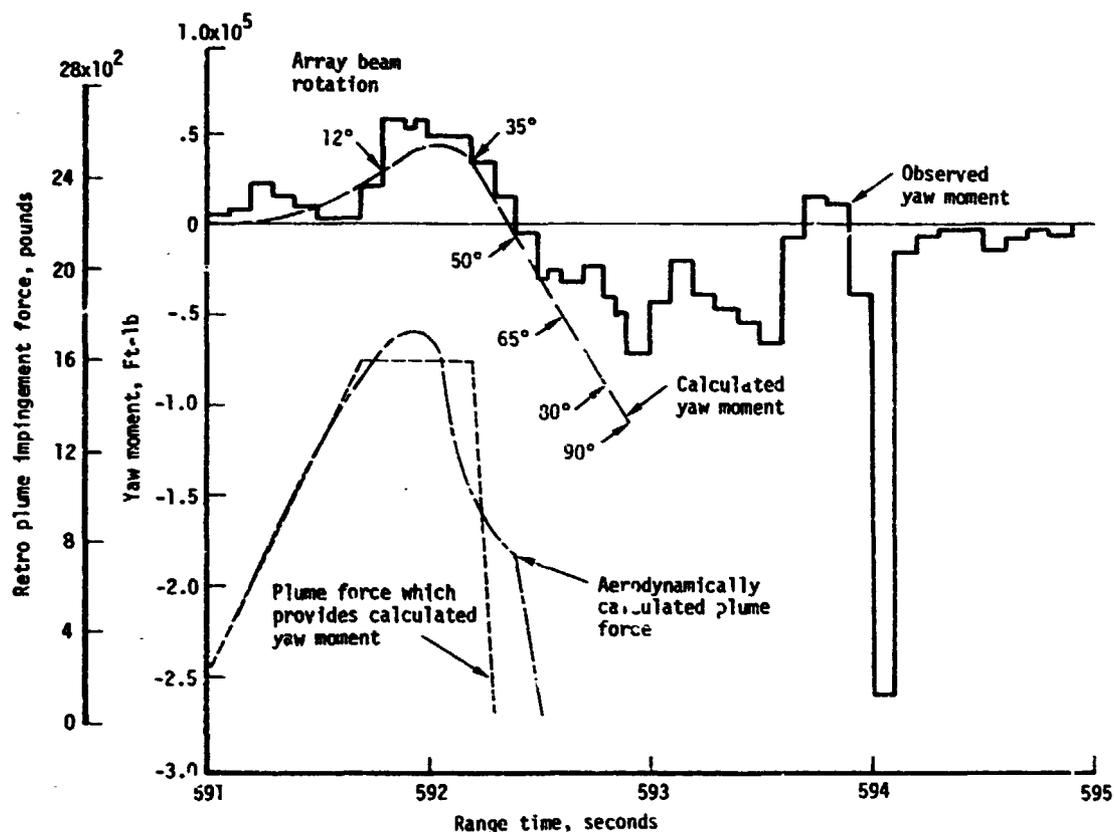
Figure 4-25.- Plume impingement force on solar array wing 2.

The following sequence of events is believed to have occurred. At 591.1 seconds, the retrorocket ignition command was initiated, and plume impingement caused a positive yaw rate buildup and a reduction in the positive pitch rate. At 592.3 seconds, array wing 2 deployed into the plume of the retrorocket in I-IV quadrant and began to affect rigid body rates, causing a large negative roll rate and a small negative pitch rate increment. This impingement force deformed the arm as a cantilever beam in the -Z direction and produced a negative yaw rate which overcame the positive rate previously induced by plume impingement on the workshop. The retrorocket plume impingement also accelerated the deployment rate of array wing 2. These retrorocket exhaust plume impingement forces are shown in figure 4-25.

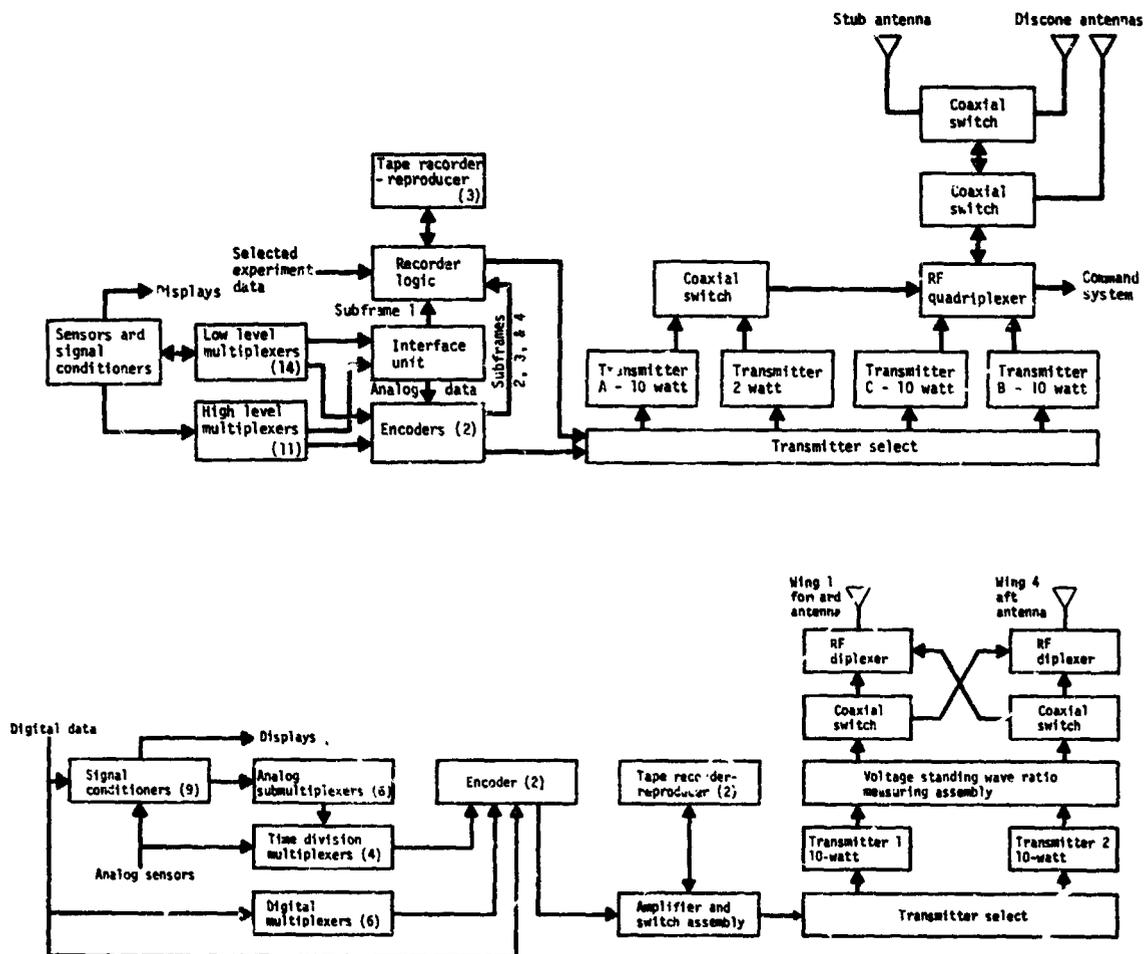
Figure 5-3.- Solar observatory data system.

transmission. Sensors, signal conditioners, multiplexers, transmitters, antennas, and related circuitry are used to perform this operation. The Saturn Workshop data systems sampled 2060 sensors at various rates and coded their outputs into 8- or 10-bit words, producing 123,200 data bits per second. While in contact with the ground stations, about 32 percent of the time, all RF data were transmitted in real time. During the 68 percent of the flight time when there was no station contact, selected data were recorded onboard for subsequent transmission. These data constituted approximately 40 percent of the total data transmitted. The solar observatory, including its data transmission system, is enclosed by the shroud during launch, and measurements required for launch and early-deployment performance information are processed through the laboratory system. Dynamics and acoustic measurements during launch were transmitted through the launch vehicle system, which had analog data transmission capability. Diagrams of the data systems are shown in figures 5-2 and 5-3.

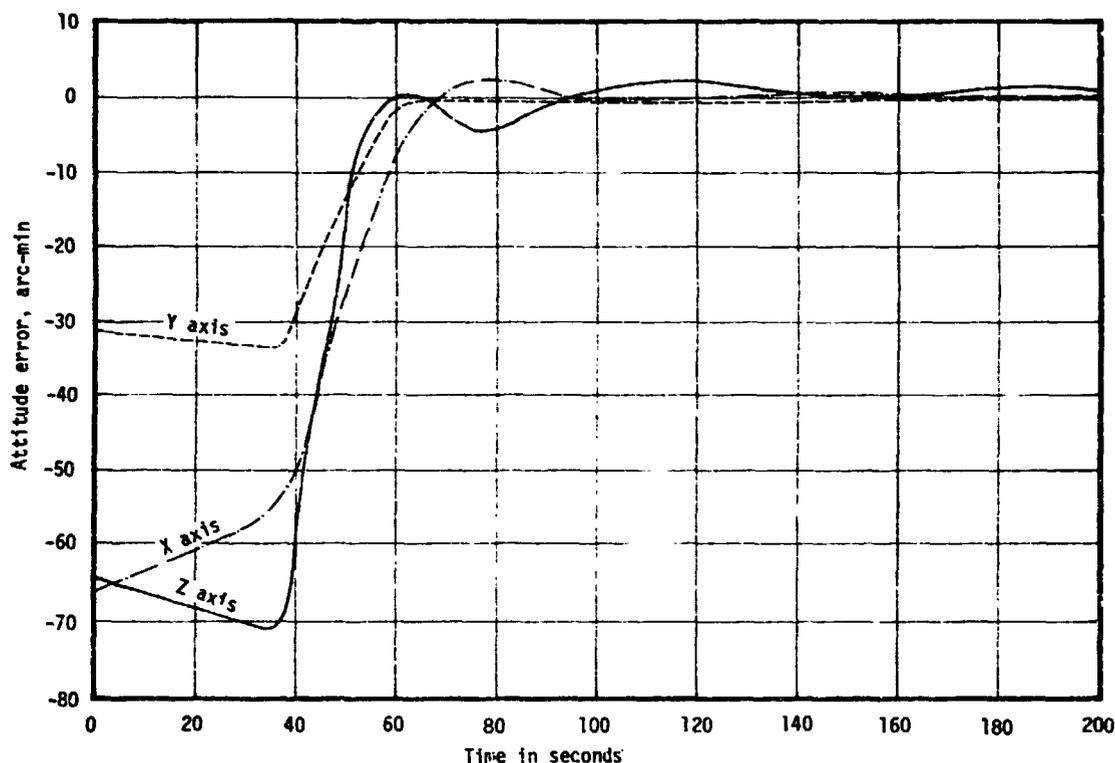
Figure 6-11.- Attitude error during initial solar inertial attitude acquisition with control moment gyros.

Dynamic Stability.- The dynamic behavior of the attitude error as the solar inertial attitude was acquired for the first time using control moment gyros (on Day 2 at 11:48 Gmt) is shown in figure 6-11. During an unmanned, quiescent period on Day 2, observed pointing accuracies in all axes were 0.4 arc-min with an uncertainty of 0.4 arc-min. Stability for 15-minute intervals was also  $0.4 \pm 0.4$  arc-min. Jitter was observed to be about 0.4 arc-min/sec. During a manned, quiescent period on Day 14, the pointing accuracies observed were as good as they were in the unmanned period, but the stability and jitter errors increased slightly. Worst stability was 1.4 arc-min, and worst jitter was 1.2 arc-min/sec. This performance observed early in the mission was well within system performance requirements.

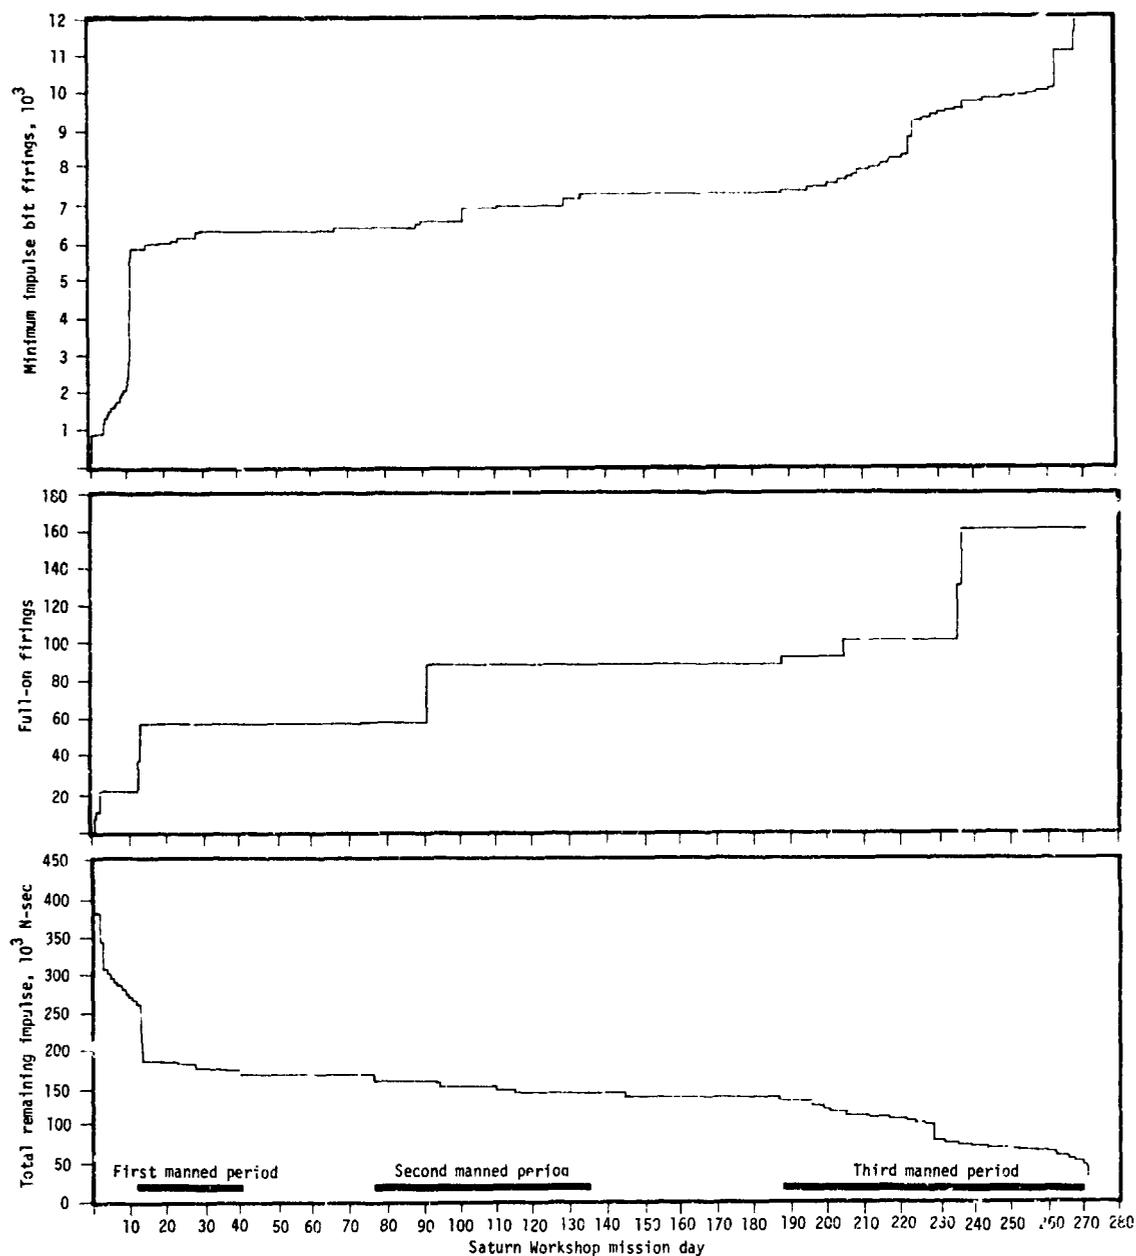
Figure 6-12.- Thruster usage history.

At launch, the Saturn Workshop was loaded with 374,000 N-sec of impulse capability, and the predicted normal usage was 162,000 N-sec. The actual usage was 338,000 N-sec. Figure 6-12 shows the usage history. Maintaining the thermal attitude required high thruster gas usage. A large portion of the thruster fuel was used during such abnormal situations. Usage was also higher than expected during extravehicular activity because suit ventings caused more torque on the vehicle than predicted. The deflector was removed from the pressure control unit on subsequent extravehicular activities to minimize the venting torques. Normal usage was consistent with preflight predictions.

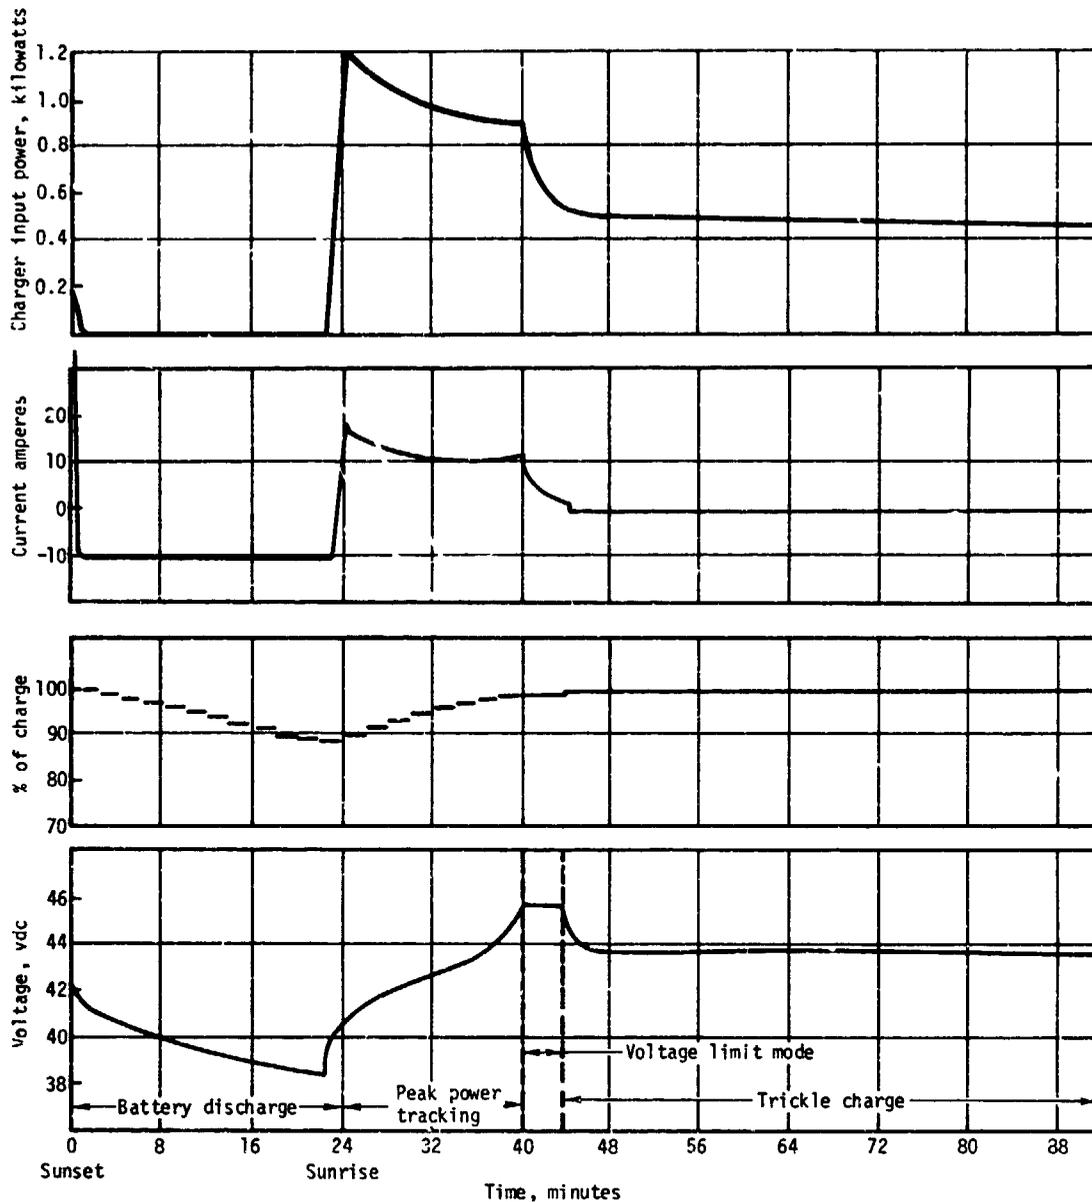
Figure 7-14.- Typical discharge-charge cycle operation for a power conditioner.

Peak Power Tracking.- Peak power tracking is experienced from the beginning of each sunlight period until the battery is fully charged. Available solar array power is maximum at sunrise, and gradually decreases as the solar array group temperature increases. The peak power tracking portion of the charger input power curve is shown in figure 7-14. The charger peak power tracker extracted maximum power from the solar array group immediately upon sunrise and then decreased its demand as the available solar array group power decreased. As shown in the figure, the peak power tracker closely followed the characteristic solar array profile until the battery charge voltage limit mode was reached. At this time, the charger input power decreased with the reduction of battery charge current demand. This device performed satisfactorily throughout the entire mission.

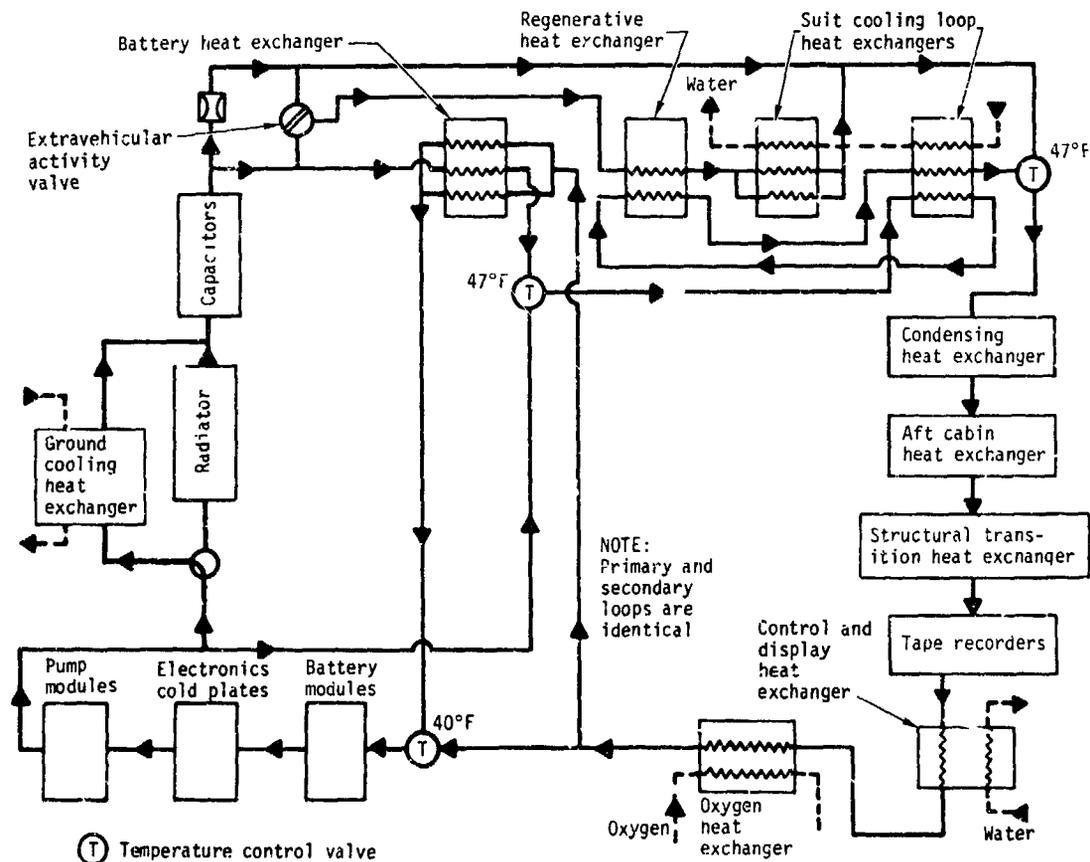
Figure 8-6.- Laboratory coolant loop.

A low-viscosity silicone ester circulating fluid, Coolanol 15, transports heat from the interior to an external radiator through two independent, parallel, nearly identical loops, designated the primary and secondary cooling loops (fig. 8-6). The coolant flows through heat exchangers for cooling and dehumidifying the atmosphere, through cold plates attached to equipment, and through a radiator for rejecting heat to space. There are also additional heat exchangers in which the coolant removes heat from fluid used in auxiliary cooling loops that have no external radiators of their own. The coolant loops also include such necessary items as pumps and valves. Wax-filled thermal capacitors store heat during the daylight side of the orbit when the radiator outlet temperature is warmer than the wax in the capacitor. Either loop can furnish the required cooling, and critical items in each loop are duplicated to increase reliability and flexibility.

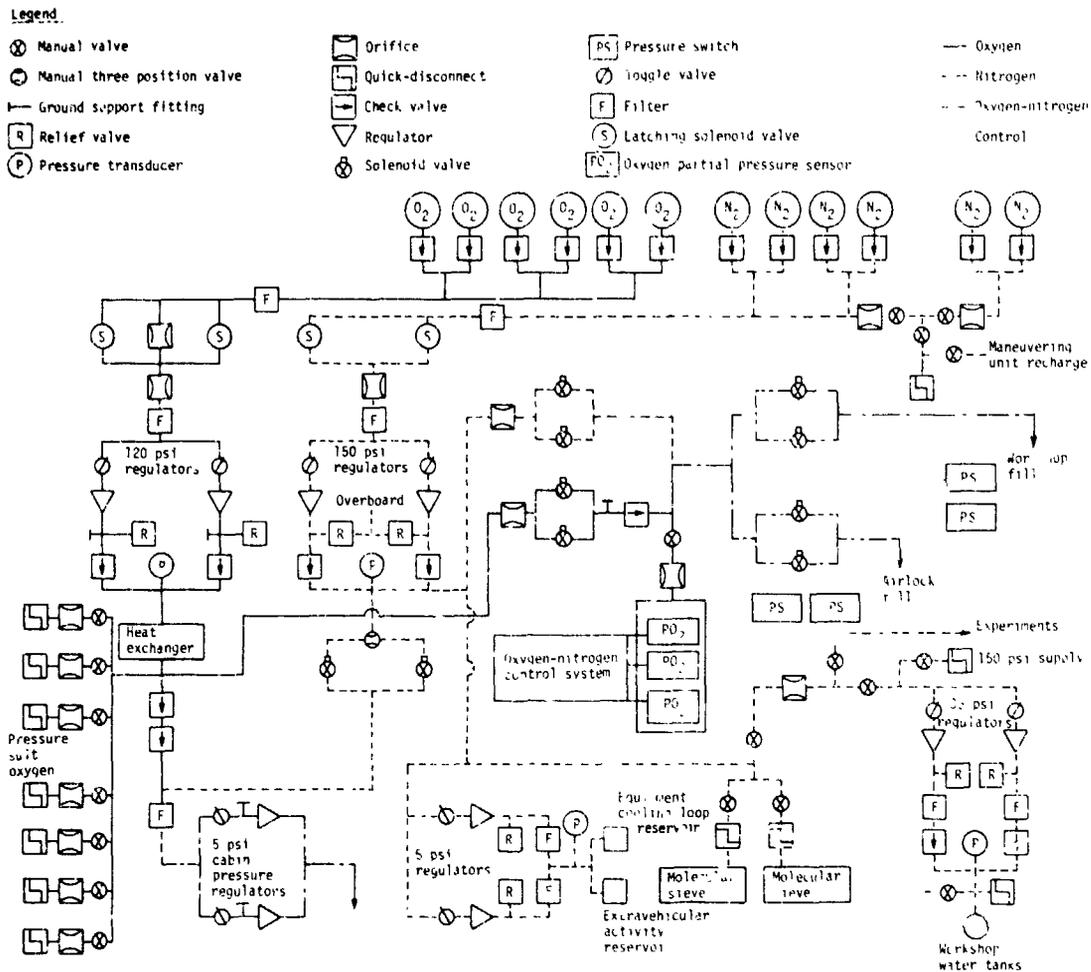
Figure 9-1.- Gas supply system.

Total gas usage during manned periods averaged about 11.5 lb/day, including metabolic consumption, leakage, and dumps. Metabolic oxygen consumption was estimated to be 5.52 lb/day, leakage about 2.68 lb/day, molecular sieve dumps about 2 to 2.5 lb/day, and miscellaneous dumps about 1 lb/day.

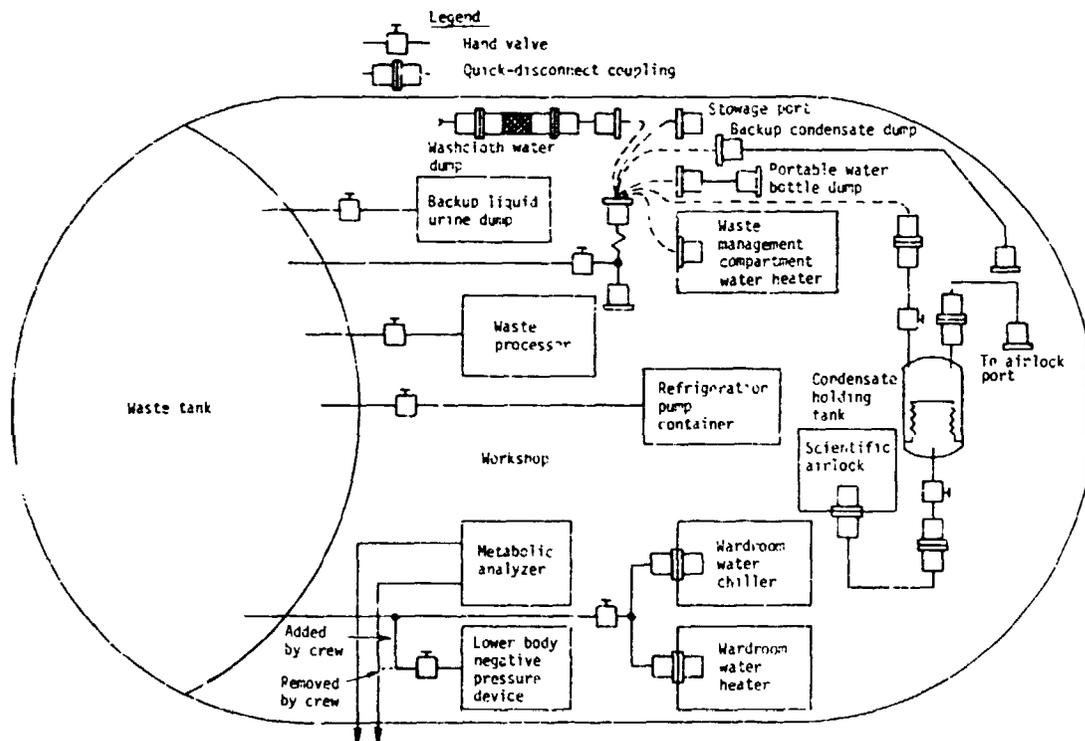
Figure 9-3.- Vacuum systems.

remained below the triple-point pressure throughout the mission. This low pressure is used to transfer fluids from the water system, washcloth squeezer, waste processor, and condensate system to the waste tank (fig. 9-3). It also serves to remove any coolant leakage in the refrigeration-pump enclosure. To eliminate the

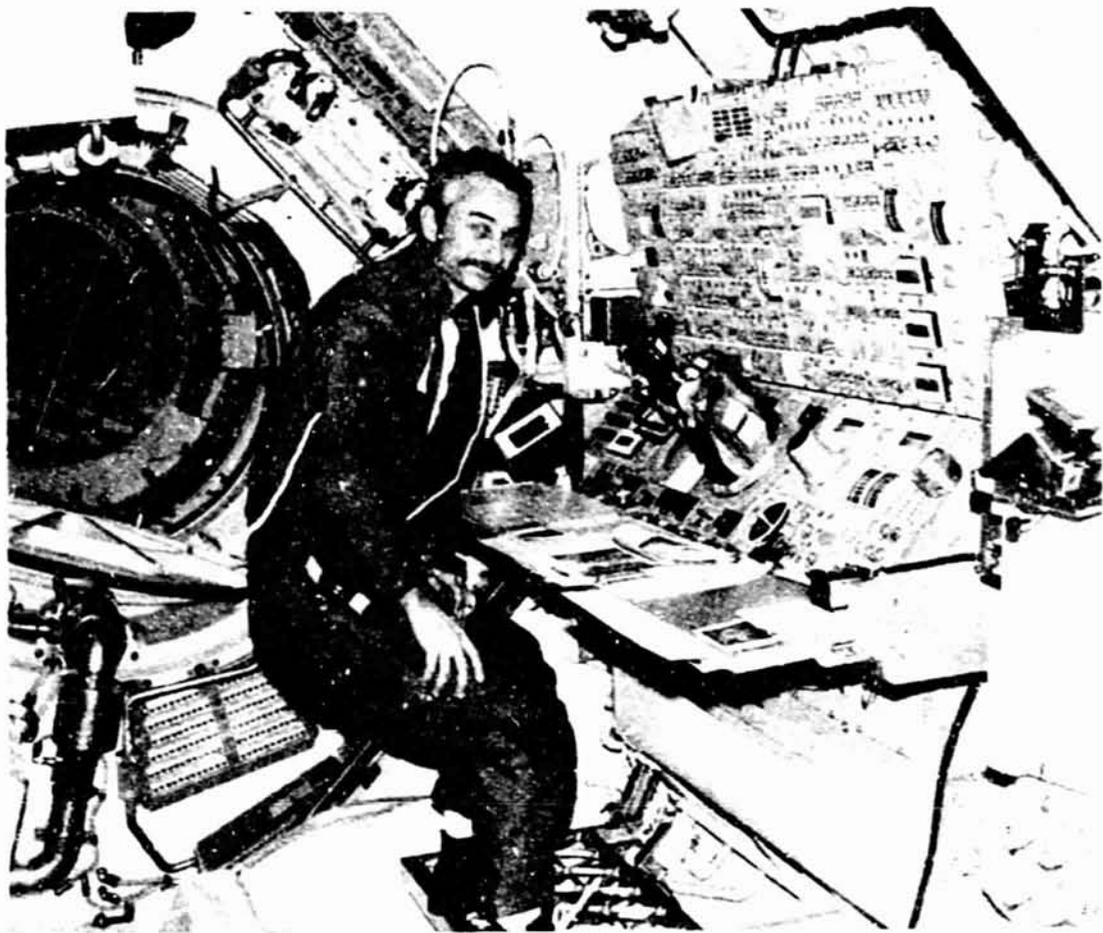
Figure 10-2.- Solar observatory console work station.

The crew comments were generally favorable, except that the crewman operating the console interfered with other crewmen translating through the laboratory or working in the area. This was an annoyance, since the console was occupied a good part of the time. Crewmen could not read their checklists by the console integral panel lighting alone. When the docking adapter floodlights were turned on, the edge lighting effect disappeared but the panel markings could still be easily read. Some crewmen preferred using the chair, and some preferred the foot restraint. Those who used the foot restraint alone found everything within easy reach. Use of the chair restricted freedom of motion and reach.
